**Flood Control Project Maintenance
Levee Inspections****LMA District Cover Sheet****Spring 2015 Levee Inspection Results****Lake County Watershed Protection District**

Spring 2015 Levee Inspection Results

Lake County Watershed Protection District

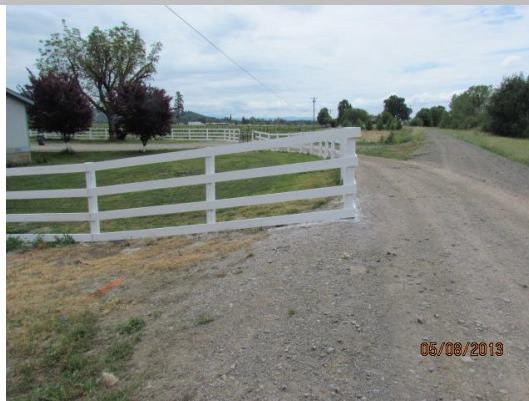
Photo 1 of 1 : SP_2015_NA0009_3_12_20150310_00006.jpg

LM Start	0.12	Rating **	M	Issue No.	12
LM End	0.12	Issue Type +	En	Location *	LS
Category	Earthen Levee			GPS Latitude/Longitude	
				Start	End
Item	Encroachments			39.188877 °	39.188877 °
				-122.907581 °	-122.907581 °
DWR ID	DWR_NA0009_01_s_2013_12				
Action/Comments					
Fence

View of the unauthorized encroachment fence along landside slope.

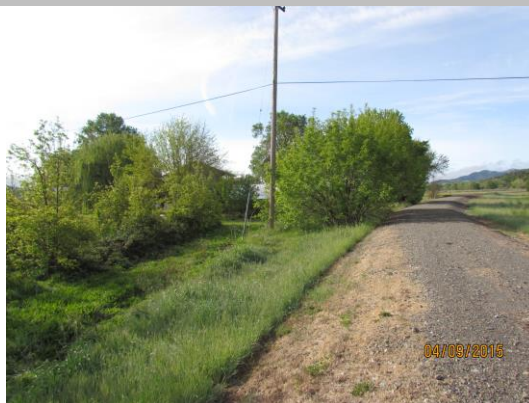
Photo 1 of 1 : SP_2015_NA0009_3_11_20150420_00094.jpg

LM Start	0.26	Rating **	M	Issue No.	11
LM End	0.26	Issue Type +	Ma	Location *	LS
Category	Earthen Levee			GPS Latitude/Longitude	
				Start	End
Item	Trim / Thin Trees			39.186777 °	39.186777 °
				-122.908102 °	-122.908102 °
DWR ID	DWR_NA0009_01_s_2013_11				
Action/Comments					
Trim and thin trees to allow visibility of the ground and room to flood fight.					
Inspector Comments: Remove the trees from the landside slope.

Remove the trees from the landside slope.

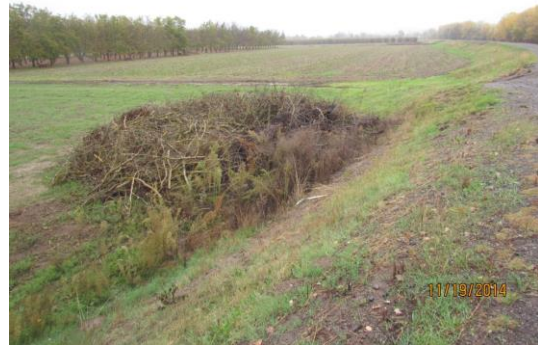
Photo 1 of 1 : SP_2015_NA0009_3_290_20150310_00012.jpg

LM Start	1.57	Rating **	M	Issue No.	290
LM End	1.57	Issue Type +	En	Location *	LS
Category	Earthen Levee			GPS Latitude/Longitude	
				Start	End
Item	Encroachments			39.169918 °	39.169918 °
				-122.915197 °	-122.915197 °
DWR ID	DWR_NA0009_01_f_2014_290				
Action/Comments					
Prunings

View of the prunings along the landside toe.

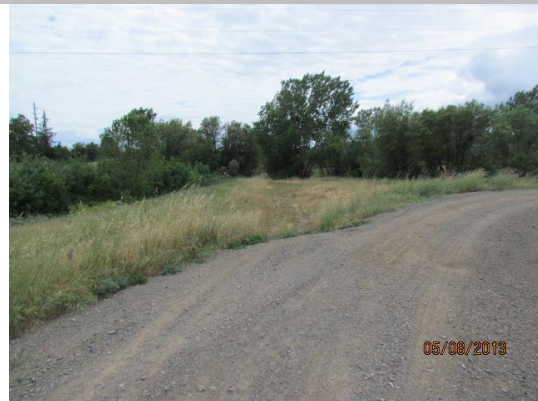
Photo 1 of 1 : SP_2015_NA0009_3_13_20150310_00007.jpg

LM Start	2.29	Rating **	M	Issue No.	13
LM End	2.29	Issue Type +	Ma	Location *	WS
Category	Earthen Levee			GPS Latitude/Longitude	
				Start	End
Item	Slope Stability			39.160285 °	39.160285 °
				-122.913481 °	-122.913481 °
DWR ID	DWR_NA0009_01_s_2013_13				
Action/Comments					
Repair the levee slope damaged by vehicle traffic and prevent access where possible.

View of the vehicle erosion along the waterside slope.

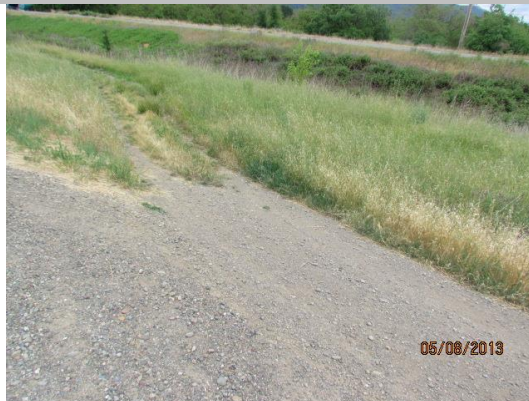
Photo 1 of 1 : SP_2015_NA0009_3_14_20150310_00008.jpg

LM Start	2.36	Rating **	M	Issue No.	14
LM End	2.36	Issue Type +	Ma	Location *	WS
Category	Earthen Levee			GPS Latitude/Longitude	
				Start	End
Item	Slope Stability			39.161153 °	39.161153 °
				-122.912740 °	-122.912740 °
DWR ID	DWR_NA0009_01_s _ 2013_14				
Action/Comments					
Repair the levee slope damaged by vehicle traffic and prevent access where possible.

View of the vehicle erosion along the waterside slope.

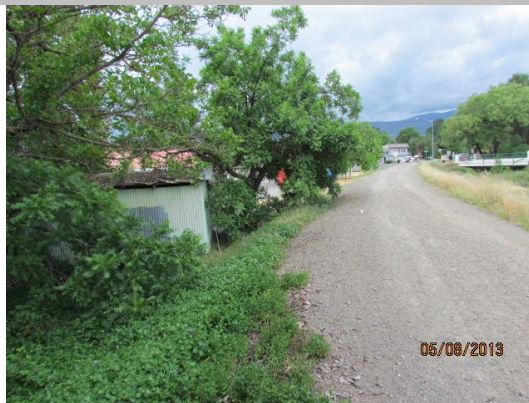
Photo 1 of 1 : SP_2015_NA0009_3_15_20150310_00009.jpg

LM Start	2.38	Rating **	M	Issue No.	15
LM End	2.41	Issue Type +	Ma	Location *	LS
Category	Earthen Levee			GPS Latitude/Longitude	
				Start	End
Item	Trim / Thin Trees			39.161381 °	39.161708 °
				-122.912551 °	-122.912168 °
DWR ID	DWR_NA0009_01_s _ 2013_15				
Action/Comments					
Trim trees to at least five feet above ground level.

Trim the trees up 5 feet to allow visibility.

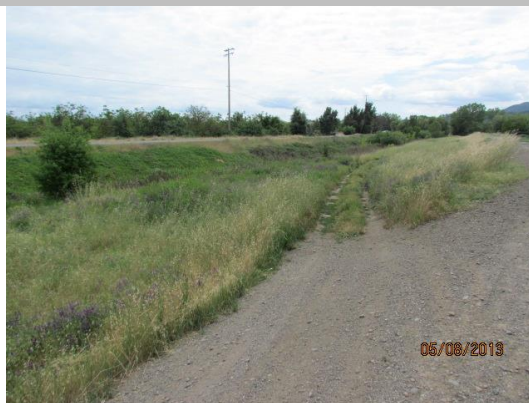
Photo 1 of 1 : SP_2015_NA0009_3_16_20150310_00010.jpg

LM Start	2.40	Rating **	M	Issue No.	16
LM End	2.40	Issue Type +	Ma	Location *	WS
Category	Earthen Levee			GPS Latitude/Longitude	
				Start	End
Item	Slope Stability			39.161601 °	39.161601 °
				-122.912303 °	-122.912303 °
DWR ID	DWR_NA0009_01_s _ 2013_16				
Action/Comments					
Repair the levee slope damaged by vehicle traffic and prevent access where possible.

View of the vehicle erosion along the waterside slope.

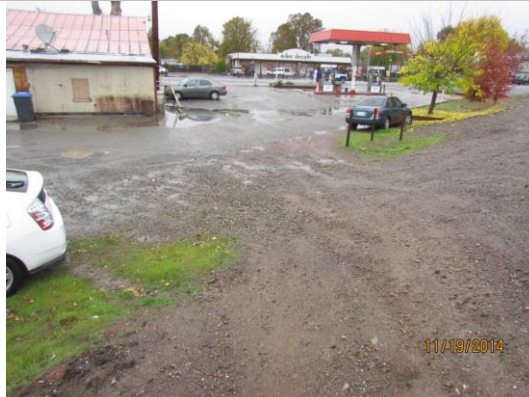
Photo 1 of 1 : SP_2015_NA0009_3_17_20150310_00011.jpg

LM Start	2.42	Rating **	M	Issue No.	17
LM End	2.42	Issue Type +	Ma	Location *	LS
Category	Earthen Levee			GPS Latitude/Longitude	
				Start	End
Item	Slope Stability			39.161802 °	39.161802 °
				-122.912020 °	-122.912020 °
DWR ID	DWR_NA0009_01_s _ 2013_17				
Action/Comments					
Repair the levee slope damaged by vehicle traffic and prevent access where possible.

View of the erosion along the landside slope.

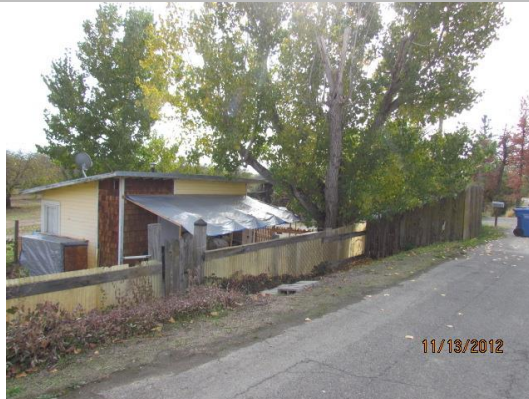
Photo 1 of 1 : SP_2015_NA0009_3_7_20150310_00004.jpg

LM Start	2.47	Rating **	M	Issue No.	7
LM End	2.59	Issue Type +	En	Location *	LS
Category	Earthen Levee			GPS Latitude/Longitude	
				Start	End
Item	Encroachments			39.161692 °	39.160217 °
				-122.911748 °	-122.912957 °
DWR ID	DWR_NA0009_01_s _ 2012_7				
Action/Comments					
Building

View of a building & fence along the toe of the levee.

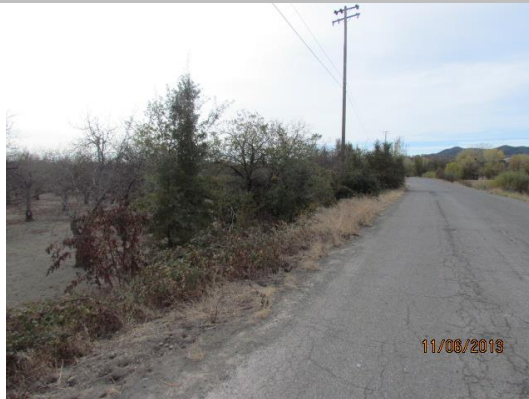
Photo 1 of 1 : SP_2015_NA0009_3_3_20150310_00001.jpg

LM Start	2.48	Rating **	M	Issue No.	3
LM End	2.54	Issue Type +	Ma	Location *	LS
Category	Earthen Levee			GPS Latitude/Longitude	
				Start	End
Item	Vegetation			39.161615 °	39.160795 °
				-122.911733 °	-122.912442 °
DWR ID	DWR_NA0009_01_s _ 2012_3				
Action/Comments					
Remove the wild growth other than native grasses from the levee slopes.

View of the vegetation along the landside slope.

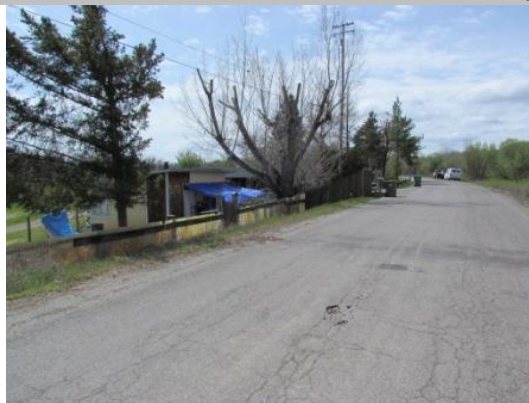
Photo 1 of 1 : SP_2015_NA0009_3_4_20150310_00002.jpg

LM Start	2.58	Rating **	M	Issue No.	4
LM End	2.62	Issue Type +	En	Location *	LS
Category	Earthen Levee			GPS Latitude/Longitude	
				Start	End
Item	Encroachments			39.160398 °	39.159952 °
				-122.912837 °	-122.913220 °
DWR ID	DWR_NA0009_01_s _ 2012_4				
Action/Comments					
Fence

View of the fences at the L/S toe.

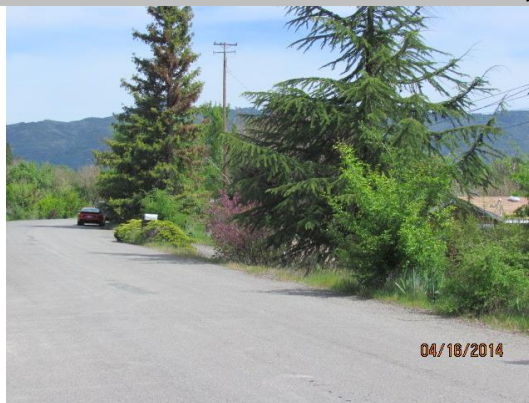
Photo 1 of 1 : SP_2015_NA0009_3_5_20150310_00003.jpg

LM Start	2.64	Rating **	M	Issue No.	5
LM End	2.64	Issue Type +	En	Location *	LS
Category	Earthen Levee			GPS Latitude/Longitude	
				Start	End
Item	Vegetation			39.159657 °	39.159657 °
				-122.913345 °	-122.913345 °
DWR ID	DWR_NA0009_01_s _ 2012_5				
Action/Comments					
Landscaping

View of the landscape along the landside slope.

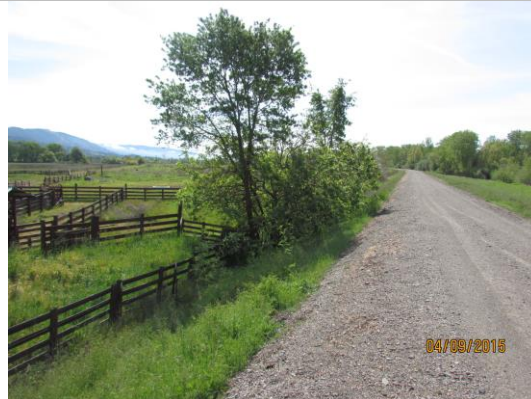
Photo 1 of 1 : SP_2015_NA0009_3_534_20150420_00095.jpg

LM Start	3.24	Rating **	M	Issue No.	534
LM End	3.24	Issue Type +	Ma	Location *	LS
Category	Earthen Levee			GPS Latitude/Longitude	
				Start	End
Item	Trim / Thin Trees			39.151148 °	39.151148 °
				-122.913652 °	-122.913652 °
DWR ID	DWR_NA0009_01_s _ 2015_534				
Action/Comments					
Thin trees to allow visibility of the ground and room to flood fight.

Remove the trees from the landside toe.

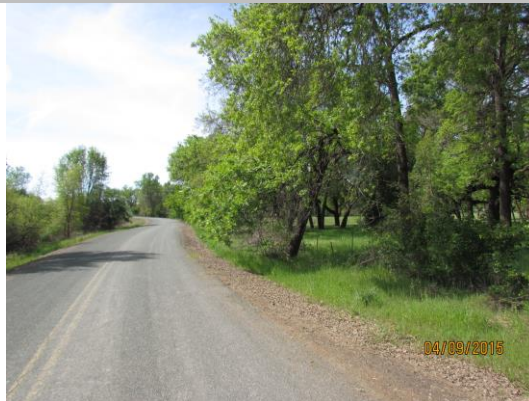
Photo 1 of 1 : SP_2015_NA0009_4_4_20150420_00112.jpg

LM Start	0.02	Rating **	M	Issue No.	4
LM End	0.14	Issue Type +	Ma	Location *	LS
Category	Earthen Levee			GPS Latitude/Longitude	
				Start	End
Item	Trim / Thin Trees			39.189540 °	39.187900 °
				-122.908065 °	-122.908655 °
DWR ID	DWR_NA0009_02_s _ 2013_4				
Action/Comments					
Trim trees to at least five feet above ground level.

Trim the trees of 5 feet to allow visibility.

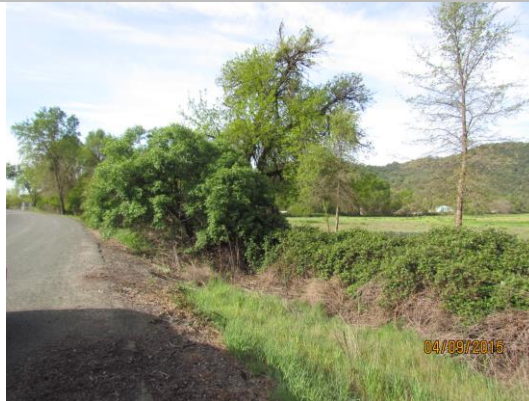
Photo 1 of 1 : SP_2015_NA0009_4_19_20150420_00113.jpg

LM Start	0.08	Rating **	M	Issue No.	19
LM End	0.08	Issue Type +	Ma	Location *	LS
Category	Earthen Levee			GPS Latitude/Longitude	
				Start	End
Item	Vegetation			39.188772 °	39.188772 °
				-122.908465 °	-122.908465 °
DWR ID	DWR_NA0009_02_s _ 2014_19				
Action/Comments					
Elderberries are blocking visibility and flood fight capability.

View of the elderberries along the landside toe.

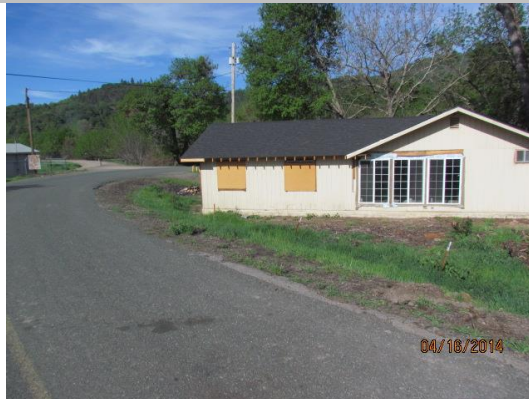
Photo 1 of 1 : SP_2015_NA0009_4_1_20150310_00001.jpg

LM Start	0.20	Rating **	U	Issue No.	1
LM End	0.20	Issue Type +	En	Location *	LS
Category	Earthen Levee			GPS Latitude/Longitude	
				Start	End
Item	Encroachments			39.187039 °	39.187039 °
				-122.908880 °	-122.908880 °
DWR ID	DWR_NA0009_02_s _ 2012_1				
Action/Comments					
Building

View of the building that all vegetation has been removed.

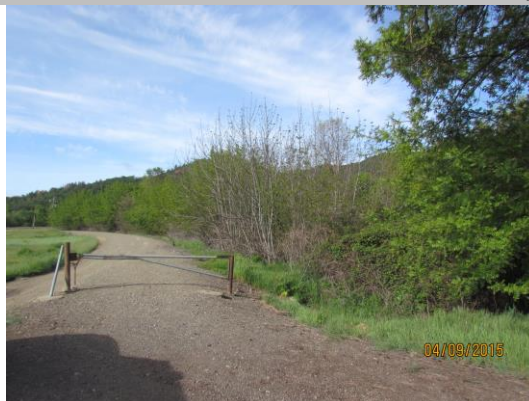
Photo 1 of 1 : SP_2015_NA0009_4_9_20150420_00114.jpg

LM Start	0.24	Rating **	M	Issue No.	9
LM End	0.29	Issue Type +	Ma	Location *	LS
Category	Earthen Levee			GPS Latitude/Longitude	
				Start	End
Item	Trim / Thin Trees			39.186739 °	39.186038 °
				-122.909436 °	-122.909948 °
DWR ID	DWR_NA0009_02_s _ 2013_9				
Action/Comments					
Thin trees to allow visibility of the ground and room to flood fight.

Trim the trees up 5 feet to allow visibility.

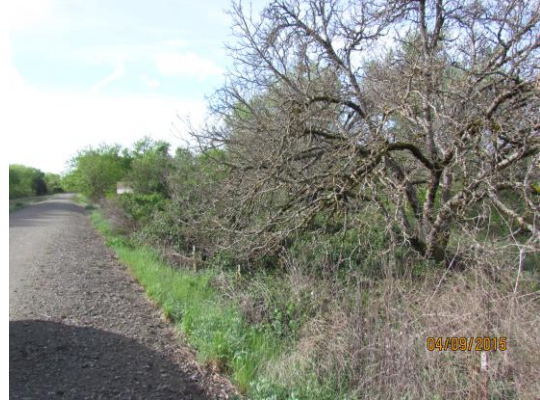
Photo 1 of 1 : SP_2015_NA0009_4_7_20150420_00115.jpg

LM Start	0.97	Rating **	M	Issue No.	7
LM End	0.98	Issue Type +	Ma	Location *	LS
Category	Earthen Levee			GPS Latitude/Longitude	
				Start	End
Item	Vegetation			39.177218 °	39.176992 °
				-122.913673 °	-122.913642 °
DWR ID	DWR_NA0009_02_s _ 2012_7				
Action/Comments					
Remove the wild growth other than native grasses from the levee slopes.					
Inspector Comments: Remove the vegetation from the landside toe.

Remove the vegetation from the landside toe.

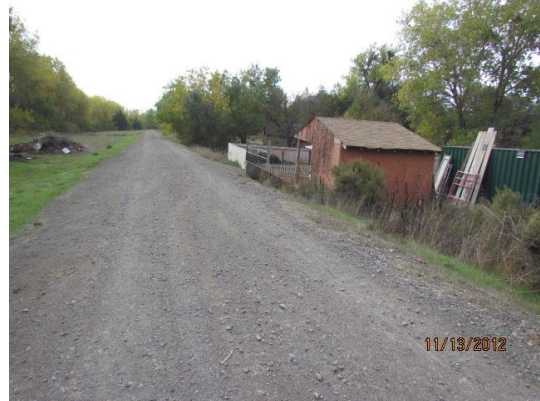
Photo 1 of 1 : SP_2015_NA0009_4_5_20150310_00005.jpg

LM Start	0.99	Rating **	M	Issue No.	5
LM End	0.99	Issue Type +	En	Location *	LS
Category	Earthen Levee			GPS Latitude/Longitude	
				Start	End
Item	Encroachments			39.176875 °	39.176875 °
				-122.913685 °	-122.913685 °
DWR ID	DWR_NA0009_02_s _ 2012_5				
Action/Comments					
Building

View of building & vegetation along the levee toe.

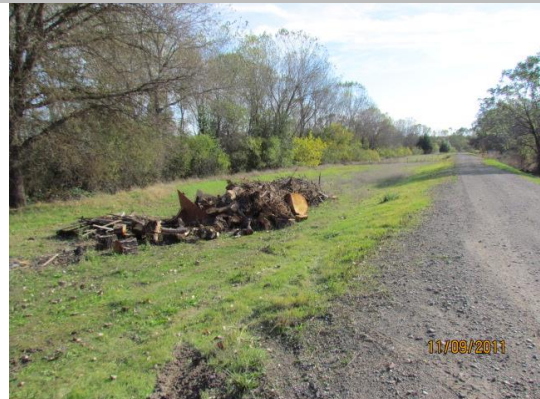
Photo 1 of 1 : SP_2015_NA0009_4_3_20150310_00003.jpg

LM Start	0.99	Rating **	M	Issue No.	3
LM End	0.99	Issue Type +	Ma	Location *	WS
Category	Earthen Levee			GPS Latitude/Longitude	
				Start	End
Item	Encroachments			39.176835 °	39.176835 °
				-122.913558 °	-122.913558 °
DWR ID	DWR_NA0009_02_s _ 2012_3				
Action/Comments					
Tree or limb

View of the tree prunings on the W/S toe.

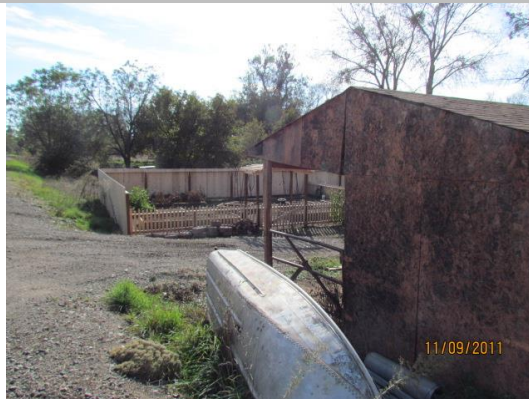
Photo 1 of 1 : SP_2015_NA0009_4_2_20150310_00002.jpg

View of the building & fence along the L/S toe.

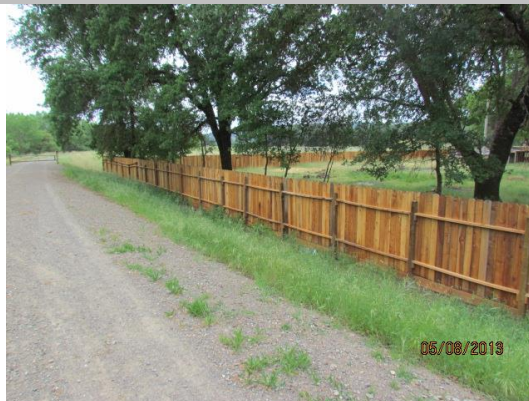
Photo 1 of 1 : SP_2015_NA0009_4_10_20150310_00007.jpg

LM Start	1.09	Rating **	U	Issue No.	10
LM End	1.11	Issue Type +	En	Location *	LS
Category	Earthen Levee			GPS Latitude/Longitude	
				Start	End
Item	Encroachments			39.175460 °	39.175075 °
				-122.913400 °	-122.913392 °
DWR ID	DWR_NA0009_02_s_2013_10				
Action/Comments					
Fence

View of the unauthorized fence along the landside toe.

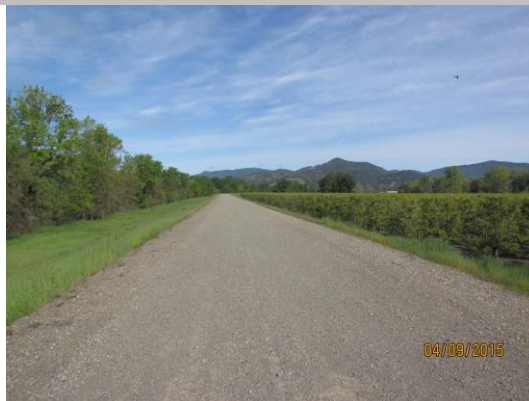
Photo 1 of 1 : SP_2015_NA0009_5_258_20150420_00085.jpg

View of the levee with vegetation on both slopes.

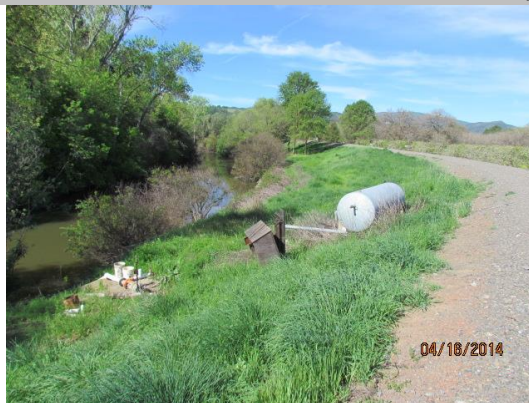
Photo 1 of 1 : SP_2015_NA0009_5_1_20150310_00001.jpg

View of the permitted tank on the waterside slope.

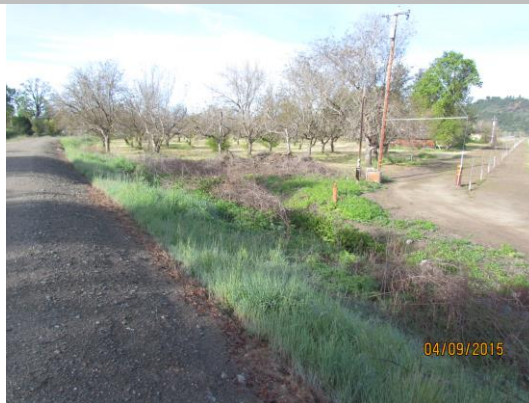
Photo 1 of 1 : SP_2015_NA0009_6_9_20150420_00065.jpg

LM Start	1.19	Rating **	M	Issue No.	9
LM End	1.26	Issue Type +	Ma	Location *	LS
Category	Earthen Levee			GPS Latitude/Longitude	
				Start	End
Item	Vegetation			39.182154 °	39.182951 °
				-122.895005 °	-122.894409 °
DWR ID	DWR_NA0009_04_s_2012_9				
Action/Comments					
Remove the wild growth other than native grasses from the levee slopes.

View of the vegetation growing at the toe.

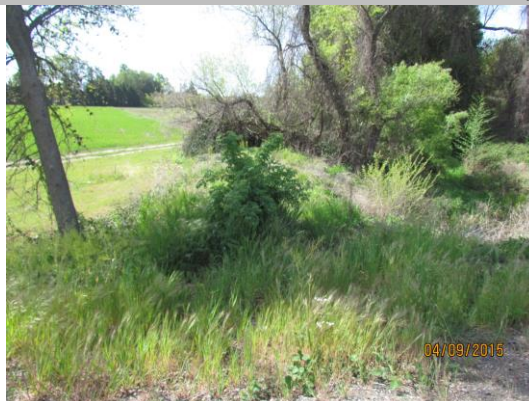
Photo 1 of 1 : SP_2015_NA0009_7_3_20150420_00031.jpg

View of the elderberry along the landside toe.

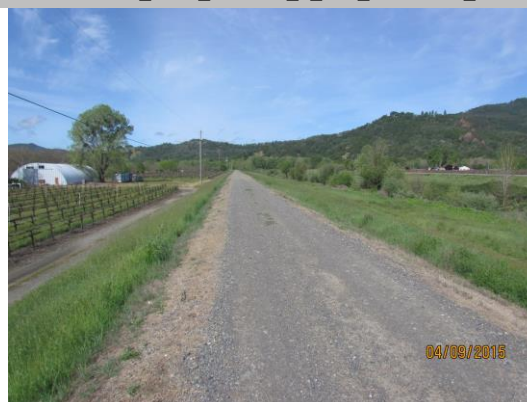
Photo 1 of 1 : SP_2015_NA0009_7_121_20150420_00033.jpg

View of the levee with vegetation on both slopes.
